**SAS Superstructure**

Daily Diary Report by Bid Item

Contract No.: 04-0120F4

Diary #: 154 Const Calendar Day: 394 Date: 07-Oct-2010 Thursday

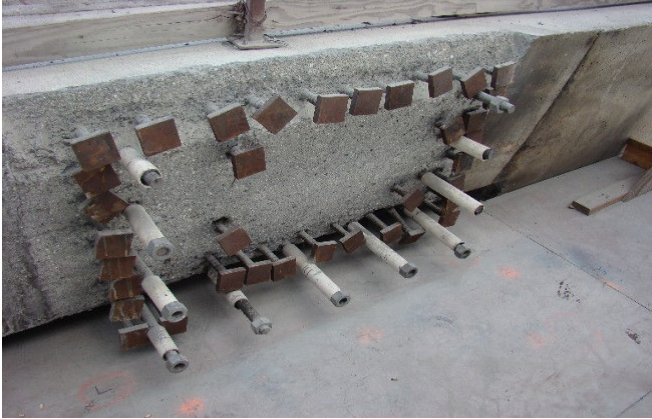
Bushed and chipped surfaces of the upper southwest bikepath pedestal blockout. Rebar wasn't placed since the wrong size bars were ordered.

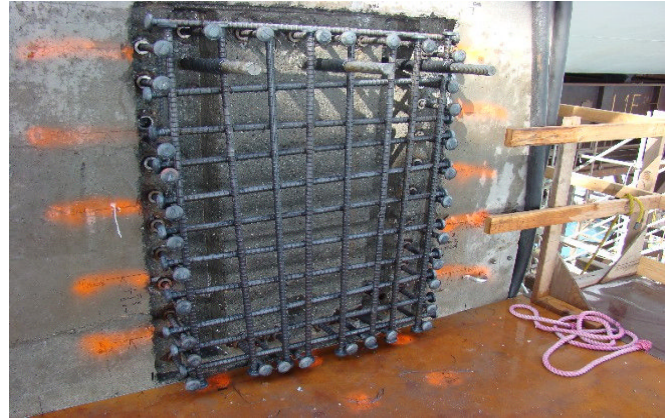
Completed placement of the lower southeast bikepath pedestal blockout.

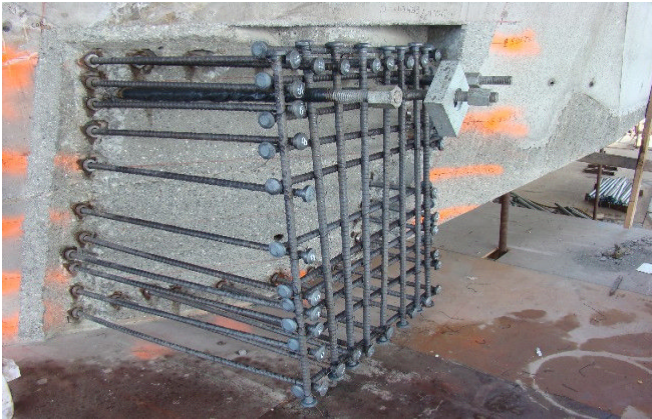
Completed placement of the lower southwest bikepath pedestal blockout.
